Tribal Science in Action:

Case Studies from Bois Forte Environmental Services' Indoor Air Quality (IAQ) Program

2) Using blower door airtightness tests, infrared thermography, visual inspections and building code study to diagnose construction flaws in new homes

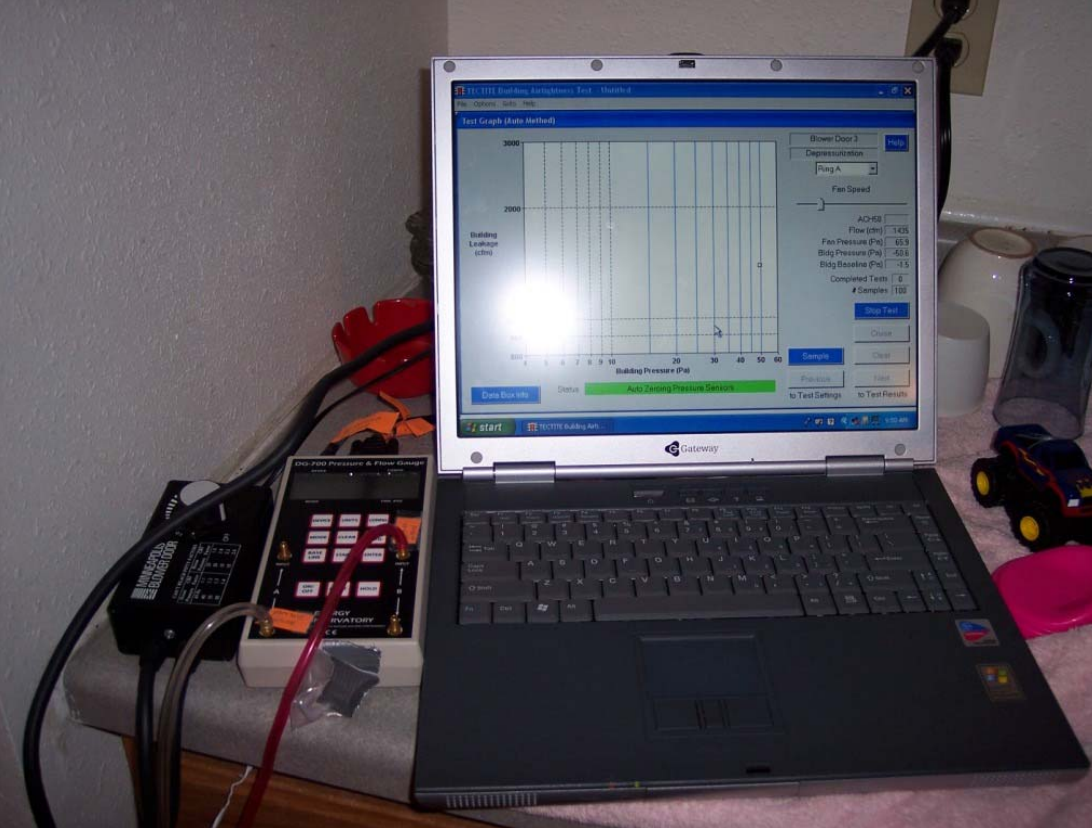
**1) House closed up,
windows locked**

**2) Tectite System and
Pressure gauge attached**

3) House Depressurized

**4) Readings taken at 8
different pressures (50
down to 15 Pascals)**

5) Airleaks searched for

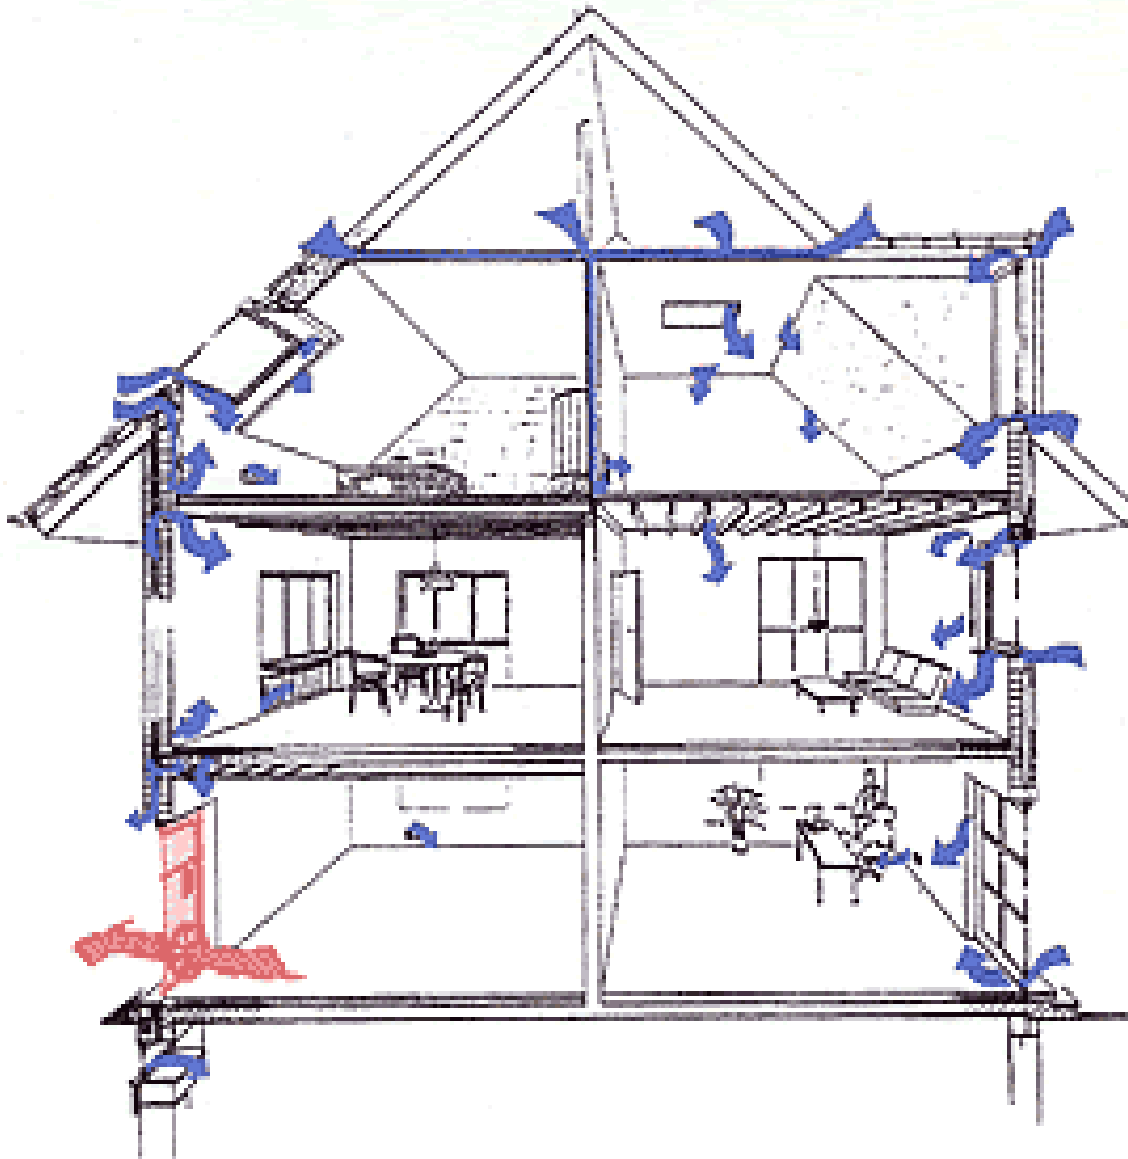
Major sources of airleakage in a home

- 1) Penetrations into attics
- 2) Top plates in attics
- 3) Around windows and doors
- 4) Air plenums
- 5) Around sill plates
- 6) Around electrical boxes

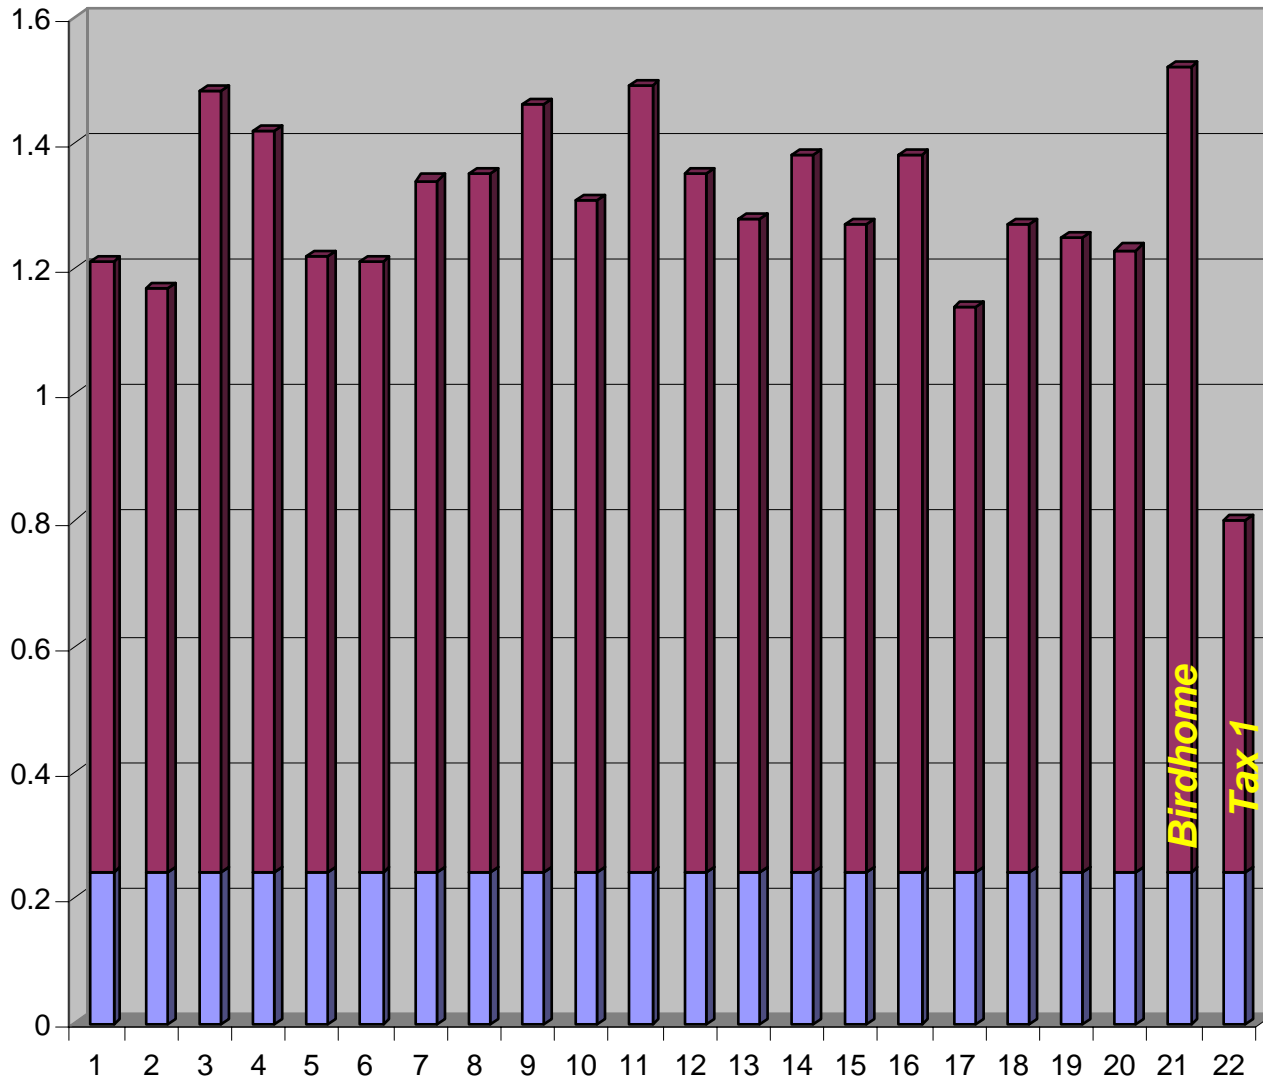
- CFM per ft2 floor area
- Code Baseline (.24)

All 20 homes were found to have consistently poor airtightness values.

Compared to the airtightness portion of the Energy Code (adopted to the MN State Building Code April 15, 2000), the homes were all found to be between 3 to 5 times leakier than the building code allows.
